UNDERWATER BRIDGE INSPECTION REPORT

STRUCTURE NO. 90608

MINNETONKA BOULEVARD

MINNESOTA DEPARTMENT OF TRANSPORTATION
UNDERWATER BRIDGE INSPECTION

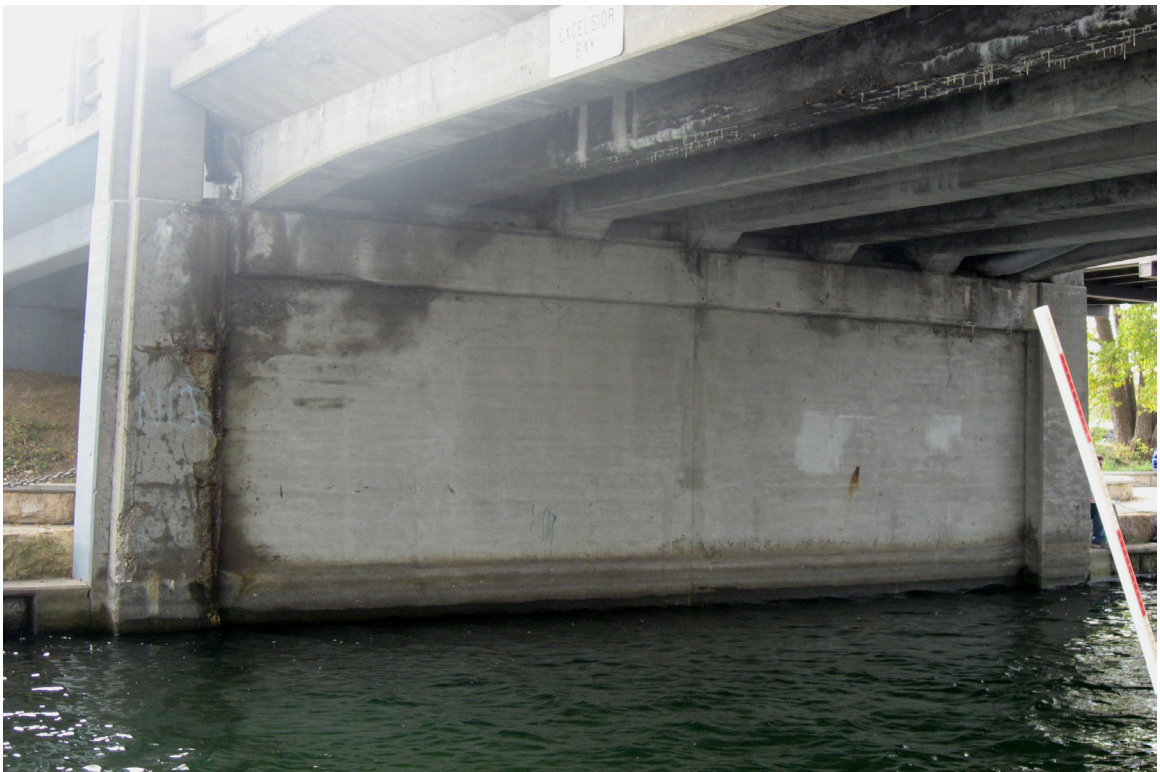
Photograph 2. View of Pier 1, Looking Southwest.

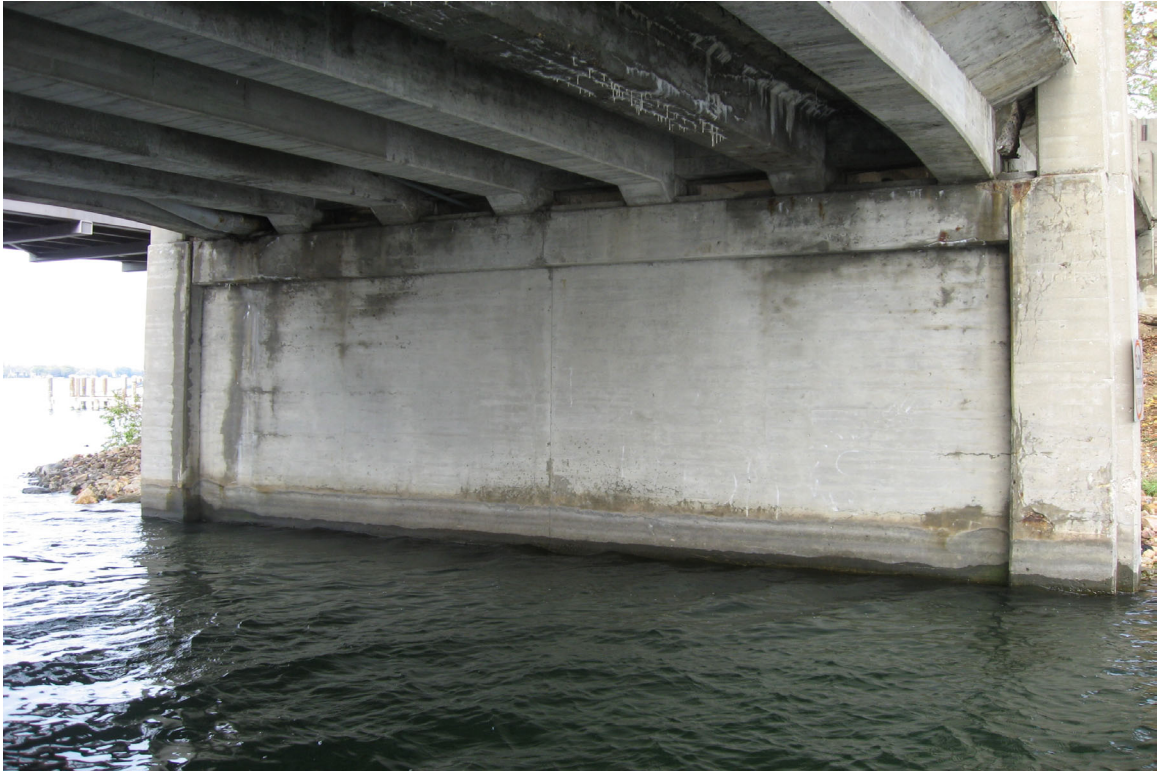
Photograph 3. View of Pier 2, Looking Northwest.

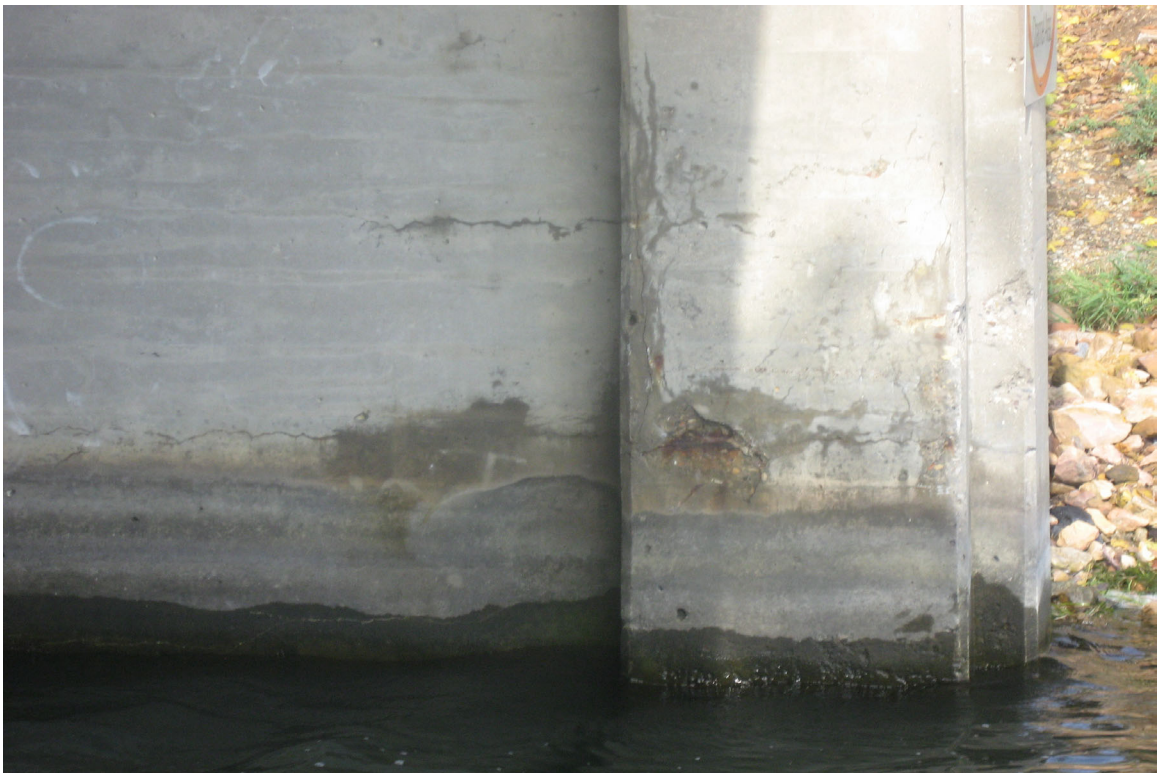
Photograph 4. View of spall with exposed reinforcement at southwest corner of east end of Pier 2, Looking North.

- A spall with impending spall with exposed reinforcing steel was observed at the southwest corner at the east end of Pier 2 and was located from 2 to 4 feet above the waterline. Area was up to 15 inches wide with a maximum penetration of 1.5 inch and exposed reinforcing steel with up to 50% section loss.

- (A) To inhibit further, more detrimental deterioration, repair the areas of section loss (spalling with exposed reinforcing steel) by removing all unsound concrete, cleaning the reinforcing steel, and patching with a concrete mix designed to promote high durability and low permeability.
- (B) Reinspect the submerged substructure units at the normal maximum recommended (NBIS) interval of five (5) years.

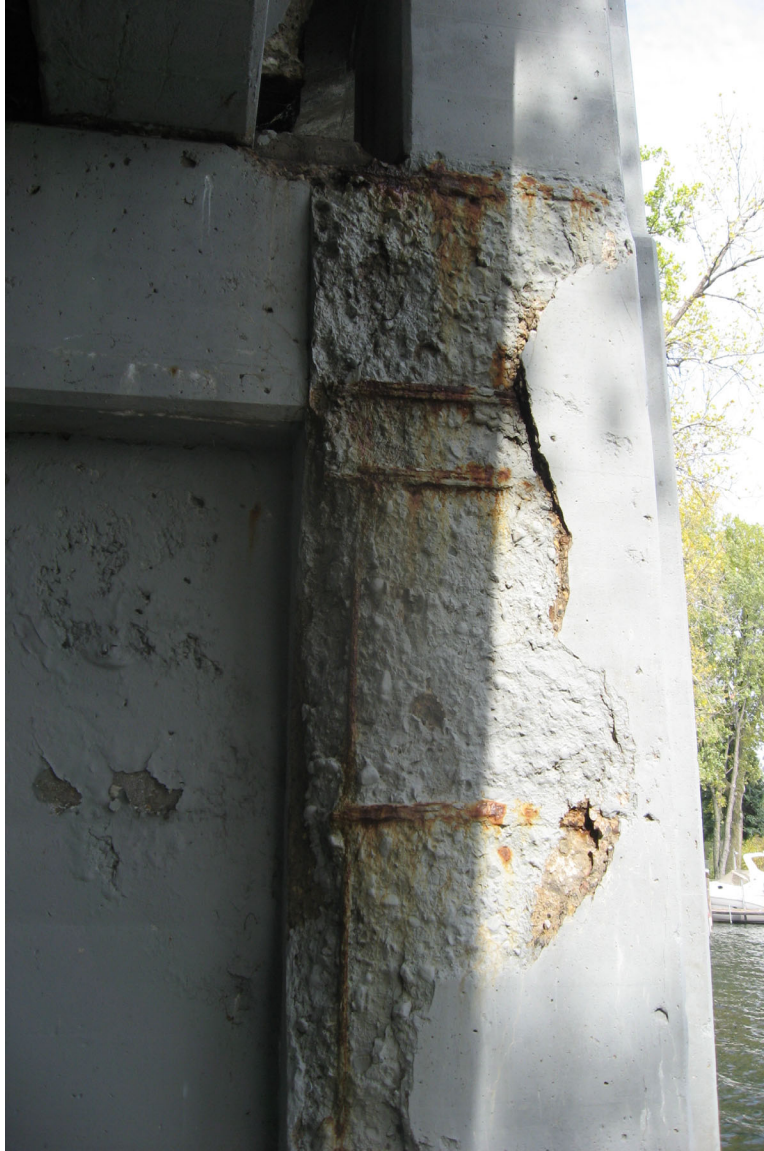
Photograph 5. View of spall with exposed reinforcement at east end of Pier 1, Looking North.

- A spall with exposed reinforcing steel was observed on the northwest corner of the east end of Pier 1 from the top of the pier cap to the waterline measuring 6 to 18 inches wide with penetrations up to 5 inches deep and 10% section loss for the reinforcing bars.

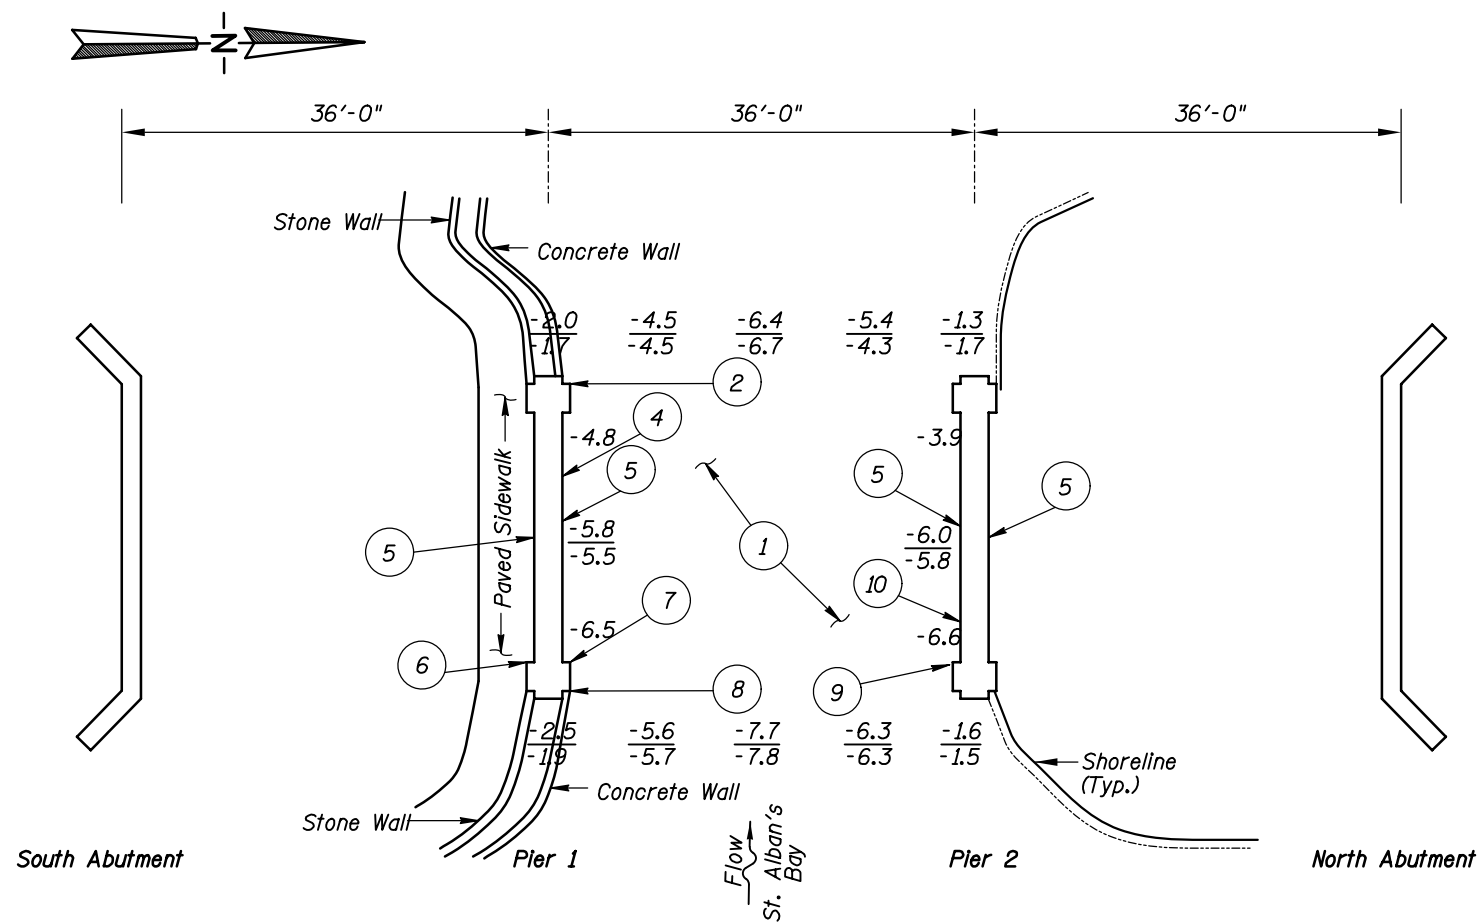
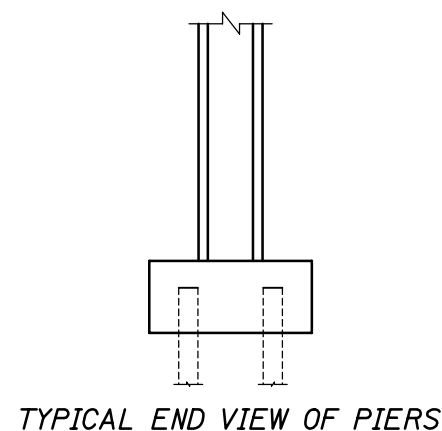
INSPECTION AND SOUNDING PLAN

- The channel bottom material consisted of sand with up to 4 inches probe rod penetration. The channel bottom along Pier 1 consisted of 1 to 2 inch diameter stone with no appreciable probe rod penetration. The channel bottom along Pier 2 consisted of sand and gravel with up to 2 inches of probe rod penetration.

- A spall was observed on the northwest corner of the west end of Pier 1 and was located at the waterline measuring 10 inches high by 18 inches wide with 1 inch maximum penetration.

- A 1/16 inch layer of marine growth was observed on all below water surfaces.
- Two Horizontal cracks were observed near the waterline. The cracks were typically 15 feet long with 1/16 inch maximum width.

- A vertical crack was observed near the center of the pier and extended from the top of the pier cap to the channel bottom with 1/8 inch maximum width. Minor section loss and differential movement up to 1/8 inch was observed in the north face crack on Pier 1 from the waterline to the channel bottom.

- A spall with exposed reinforcing steel was observed on the southwest corner of east end of Pier 1 from the top of the pier cap to 3 feet above the waterline measuring up to 3 feet in width with penetrations up to 3 inches deep.

- A spall was observed on northeast corner of the east end of Pier 1 from 1.5 feet to 3.5 feet above the waterline. Area was 8 inches wide with 2 inch penetration and with no exposed reinforcing steel.

- Three horizontal cracks were observed from waterline up 4 feet. The cracks typically extended along the entire south face of the pier and were up to 1/16 inch wide.
